FIXING GIBE II – ENGINEER’S PERSPECTIVE

Samuel Kinde¹, PhD, PE, Samson Engeda², PE

(March 2010)

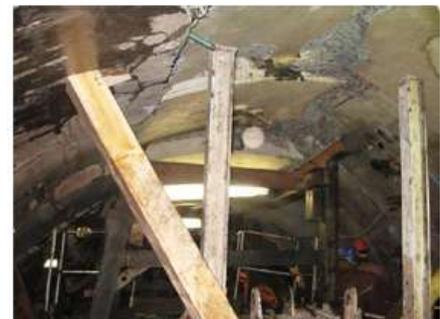
Figure 5. Image of the damaged section of Gibe II tunnel that failed in October 2006 under pressures that exceeded the design pressure by six times [6].

The first failure during the construction of the tunnel happened in **October 2006** when the tunneling crew hit a pocket of wet earth along a major fault line only 4 kilometers into the boring [6]. Wet and humid mud under a pressure of as much as 40 Bars and with temperatures reaching 40°C gushed out [6]. This immense pressure which is almost 6 times the maximum pressure of 7 Bars that the tunnel was designed for not only damaged the tunnel itself and its linings but also the 255 ton tunnel digging machine. A summary of the failures as reported by

the tunneling engineering consultant read as follows: ‘Event at the chainage 4+196 from intake heading. At the end of October 2006, the TBM was pushed back as consequence of the sudden extrusion and collapse of the tunnel face against the cutter head and the front shield. **The tunnel face moved towards the TBM 40-60 mm/hour.** The TBM has been pushed back more than 60 cm and displaced laterally more than 40 cm. As consequence, severe damages occurred to the shields, the cylinders and the last 7 segment rings installed behind the TBM.’ [6]

As it turns out, this is the second time that mud under high pressure had broken into the tunnel area. A report on an industry forum called ‘TunnelTalk’ quoting S.E.L.I. S.p.a. has suggested that the event occurred on a new location about 9kms from the outlet with affected length of almost 15m. It was also stressed that a large quantity of rock and mud fall into the tunnel [8].

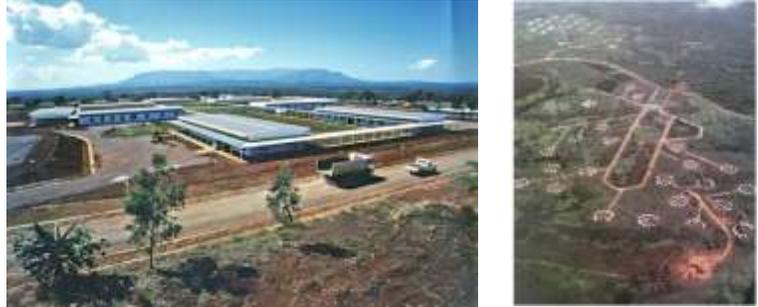
Figure 6. Studio Ing. G. Pietrangeli was involved in the design work for the original **Tana Beles Agro-Industrial Project** that was partially financed by Italy.

In our effort to assess if such structural failures as seen in the Gibe II project arise from systemic flaws or not, we investigate past large-scale projects that could shed light on this. We believe the case of the original **Tana-Beles Agro-Industrial Project** is very much relevant here. Started in 1988 through the personal involvement of the then political leader, Colonel Mengistu himself, Tana-Beles Agro-Industrial Project was a €150 million project. The financing was provided by the Italian government and both Studio G. Pietrangeli and Salini Costruttori were involved in its design and construction. This well-meaning massive project consisted of 250,000 hectares of agricultural land for 80,000 resettled farmers spread over brand new 50 villages. The supporting infrastructure included extensive road networks, water distribution, and airport. A modern hospital with general practice, surgery, pediatrics, radiology, obstetrics and gynecology departments was also included. In addition, a rice-processing factory, a pipe factory, a plastic factory, guest houses, office buildings, housing for workers, and a meeting hall were planned as part of this €150 million project.

A victim of the changing political atmosphere in the country and the politicization of the project due to the deep personal involvement of then political leaders, the project faced innumerable difficulties culminating in the withdrawal of Salini engineers from the country. Subsequently, the project turned into a desolate area and remained mostly so until 1997 where it was a scene of abandoned factories, warehouses, administrative buildings, guest houses, roads and bridges [9]. In the late 90s, only 30,000 out of 80,000 re-settled people remained in the area. Others reportedly died of malaria, famine, diarrhea; some managed to escape [9]. Currently, there is some rehabilitation of the project in somewhat distinctly different form as the Tana-Beles Multi-Purpose project.

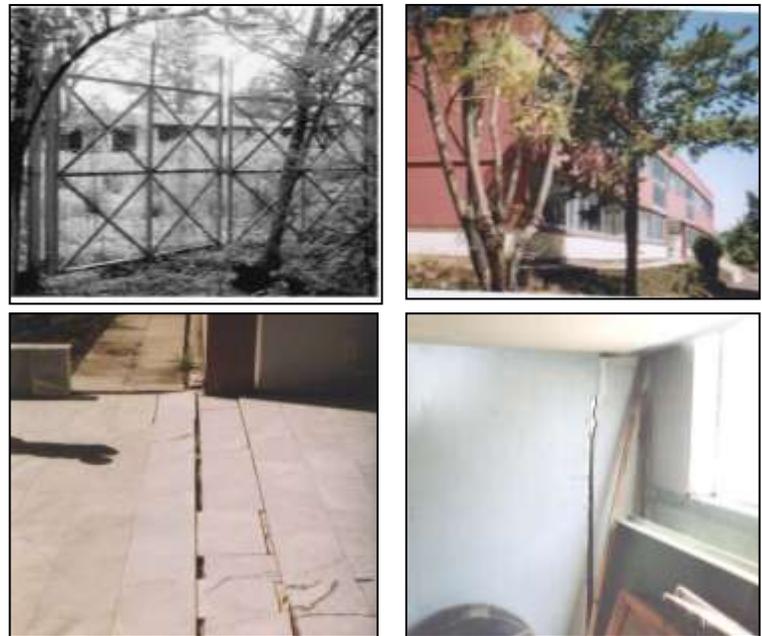
Figure 7. A closed and desolate rice-processing factory in the original **Tana-Beles** project [9]. The other three pictures show foundation Failure of three buildings at the **Akaki Spare Parts Factory** [10].

The second example is that of the **Akaki** Spare Parts factory that was built in the late 1980s by the Italian government with no input at all from their counter-part Ethiopian side. Again, we believe, the intent was noble but the most visible negative outcome of the project was the fact that it was built on a black cotton soil that expands with moisture presence and then shrinks during the dry season. The absence of simple engineering ‘sanity-check’ by independent review system from the Ethiopian side resulted in the structure functionally damaged with foundation failures that translated to multitudes of structural cracks in the walls, floors, roof, windows, doors, etc [10]. The structure continues to be a dangerous structure; but due to lack of will and huge expenses to remedy the blunder, it is still in use.
